Citizens Complaint

Signal Peak Energy LLC's (Signal Peak or SPE) Bull Mountains Mine continues to be a scofflaw and outlier in the coal mining industry, requiring immediate enforcement, oversight, and action. Evidence from monitoring records, inspection reports, and public observations indicate that Signal Peak is again in ongoing violation of the Montana Strip and Underground

A. Litsky Spring: Signal Peak Has Failed to Monitor, Protect, and Reclaim This Critically Important Perennial Water Source.

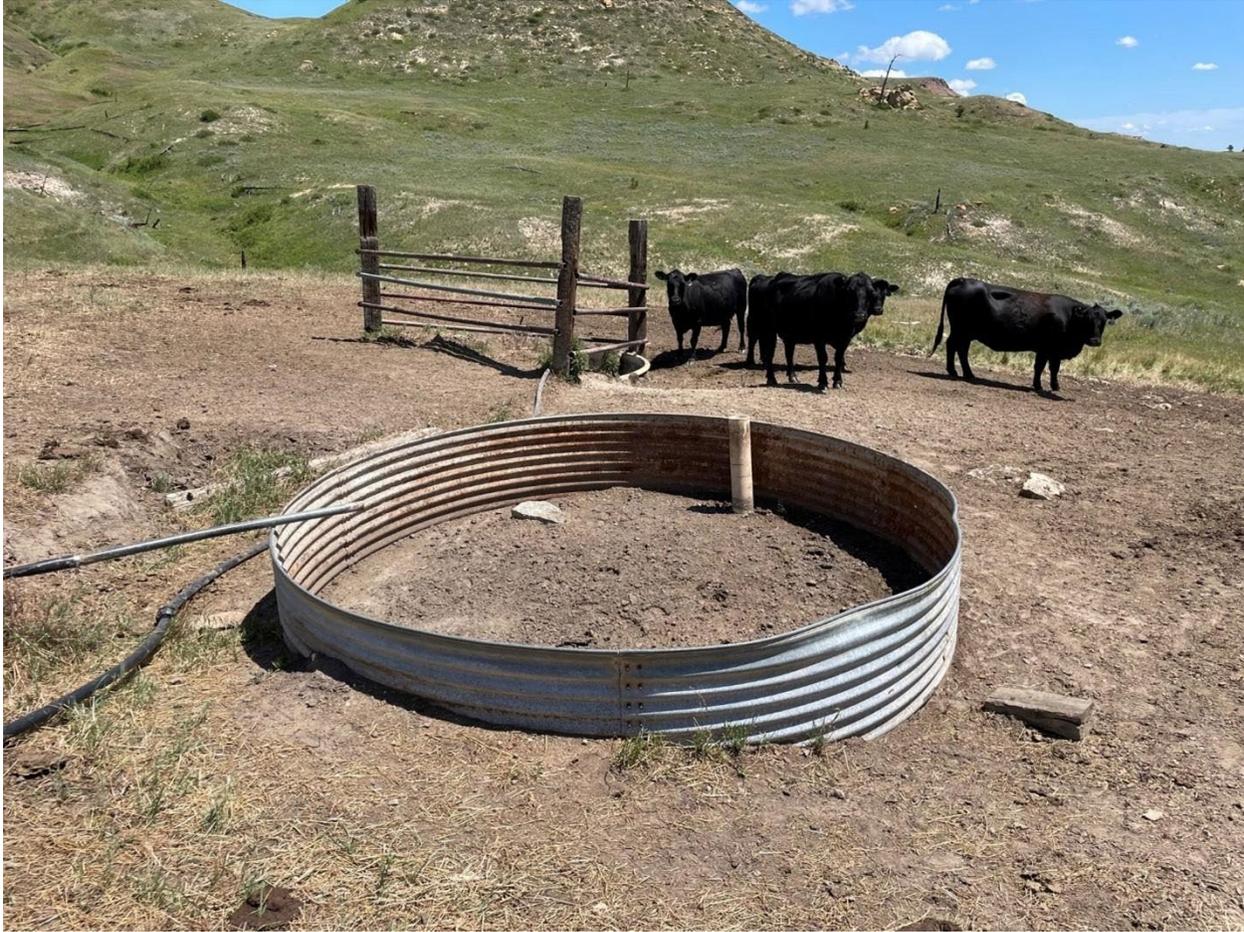
Mountain Spring (Spring 72125), a historically reliable spring identified by DEQ and Signal Peak as perennial (Permit Tbl. 304(5)-4), was undermined in 2020 and has been dry ever since. No flow measurements have been made at the spring since undermining.⁸ Substantial subsidence occurred around Mountain Spring when it was undermined.⁹ Signal Peak has

Figure 1: Mountain Spring 2022 after undermining is now dry and the cows and wildlife have no water.

provided temporary mitigation by hauling water when cattle have been present, but when cattle are not present the company has failed to provide temporary mitigation for wildlife that depend on the spring in the fall and winter months.

Again, Signal Peak's reclamation of water resources and protection of the hydrologic balance cannot be limited to existing human uses of the water. 70 Fed. Reg. 8,002, 8,004 (Feb. 16, 2005). Again, Signal Peak appears unconcerned with these impacts and has done little to rectify those effects. Signal Peak has made no effort to establish permanent mitigation at Mountain Spring.¹⁰ And Signal Peak has also failed to provide interim mitigation for wildlife. Signal Peak's failure to reclaim the spring violates its obligation to protect and restore water resources. 30 U.S.C. §§ 1202(e), 1258(a)(13), 1265(b)(2), (10); Mont. Code Ann. § 82-4-231(1), (10)(k); ARM 17.24.648, 903(2), 1116(6)(d); Permit App. 313-2 at 313-2-3.
